### RESEARCH MEMORANDUM

VIBRATION SURVEY OF BLADES IN 10-STAGE

AXIAL-FLOW COMPRESSOR

II - DYNAMIC INVESTIGATION

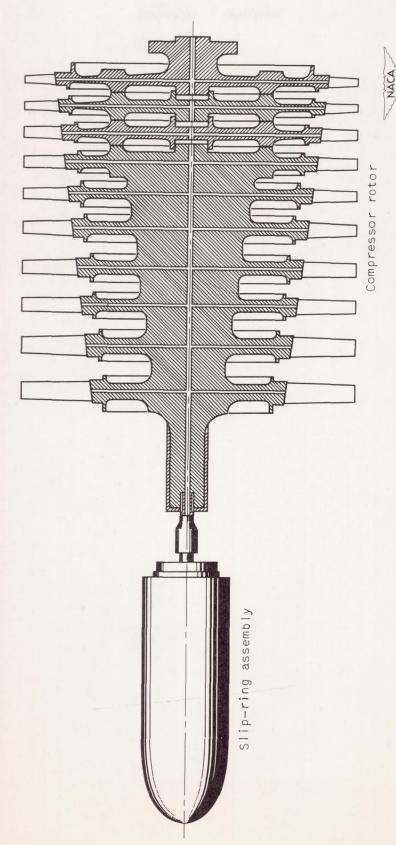
Axial-flow compressor rotor drilled for strain-gage lead wires.

The operating range of the equipment was limited to a compressor speed of 14,000 rpm by lack of driving power, although the compressor is rated at 17,000 rpm. Unfortunately, conclusive data on the last five stages were not obtained because some of the lead wires were thrown out by centrifugal force during the elapsed running time needed to eliminate instrumentation difficulties. The lead-wire failures were attributed to poor adhesion and faulty void filling by the ceramic cement.

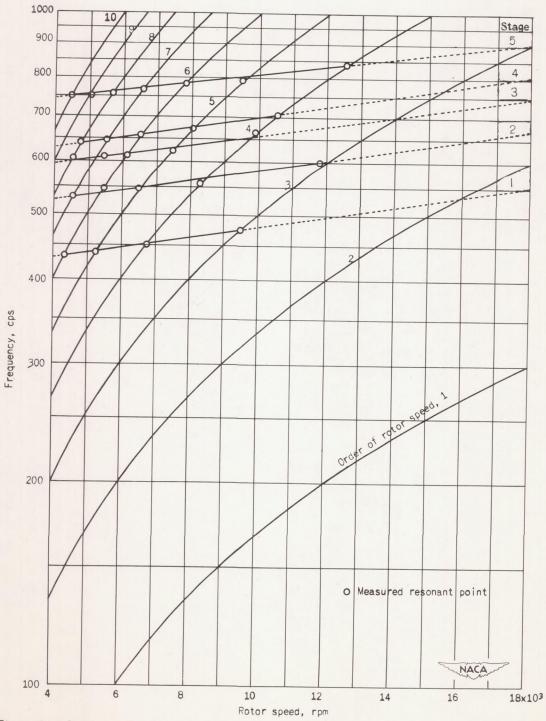
Figure 6. - Critical-speed diagram of 10-stage compressor showing only first bending-mode frequencies.

The results of the static frequency measurements made on blades of the compressor indicated that failures experienced in the seventh and tenth stages could have been caused by first bending-mode vibrations resulting from fourth- and sixth-order excitation of the rotative speed, respectively. Critical-speed diagrams illustrating this possibility are included in reference 1. The sources of the fourth- and sixth-order exciting forces have not been learned. Although four bearing supports interrupt the inlet-air stream, it is doubtful that the effect of these supports would carry as far as the seventh stage. No condition exists within the compressor that would cause six equally spaced discontinuities in the air flow.

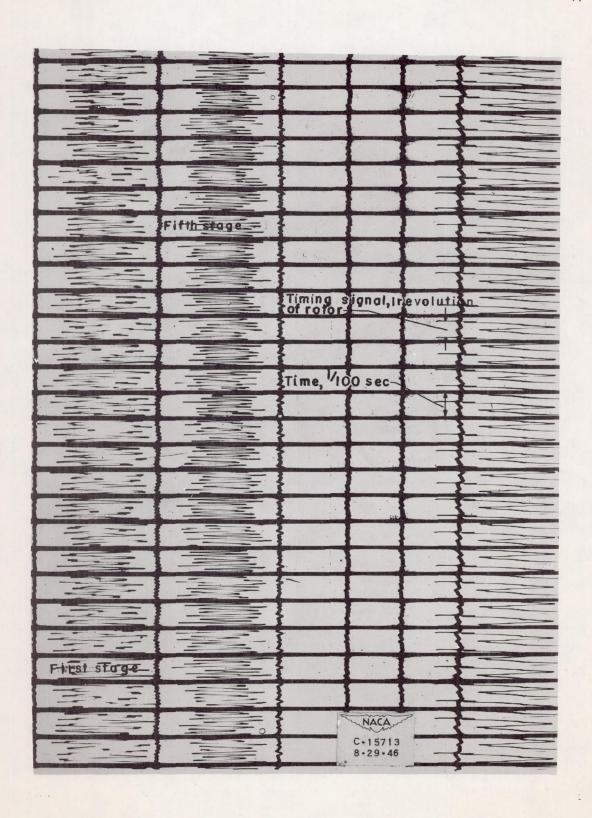
Figure 7. - Oscillograph record of representative strain-gage signals at rotor speed of 9485 rpm.

strain-gage signals from first- and fifth-stage blades that happened to resonate at the same rotor speed (9485 rpm). The vibration of the first-stage blade caused by a third-order excitation was 477 cycles per second and the measurements showed a total vibratory stress of 3700 pounds per square inch at the location of the gage. The conditions for the fifth-stage blade were a vibration of 794 cycles per second, a fifth-order excitation, and a vibratory stress of 3000 pounds per square inch. The following table gives the orders of rotor speed that were detected in the form of first bending-mode vibrations of blades in the first five stages:

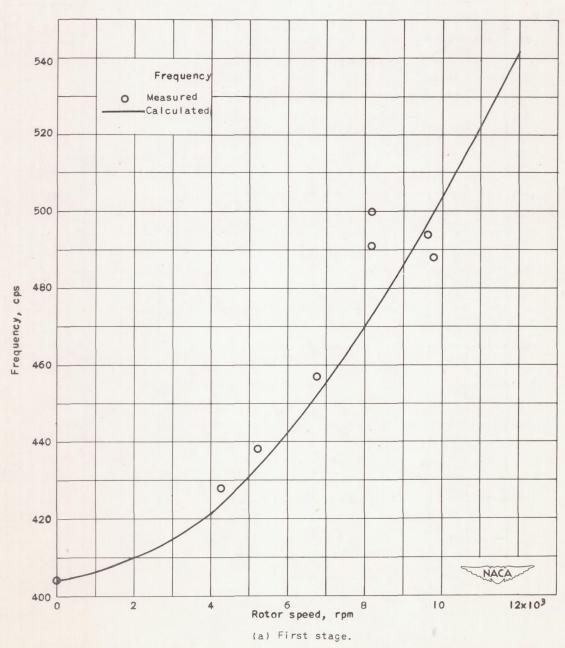
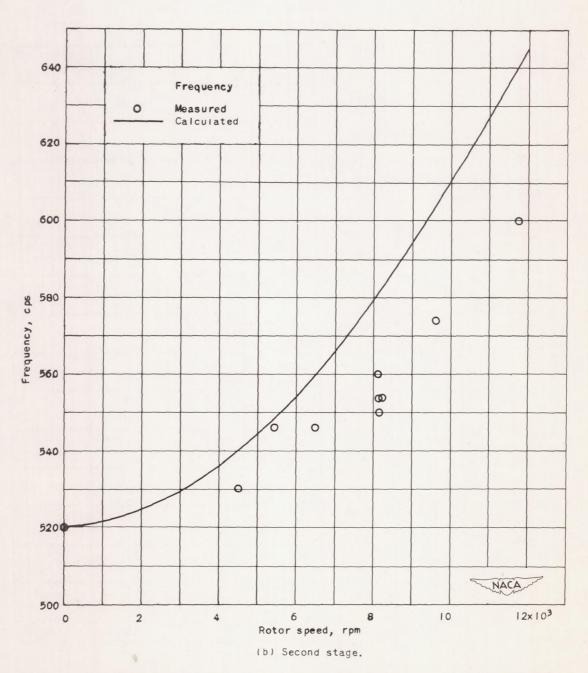
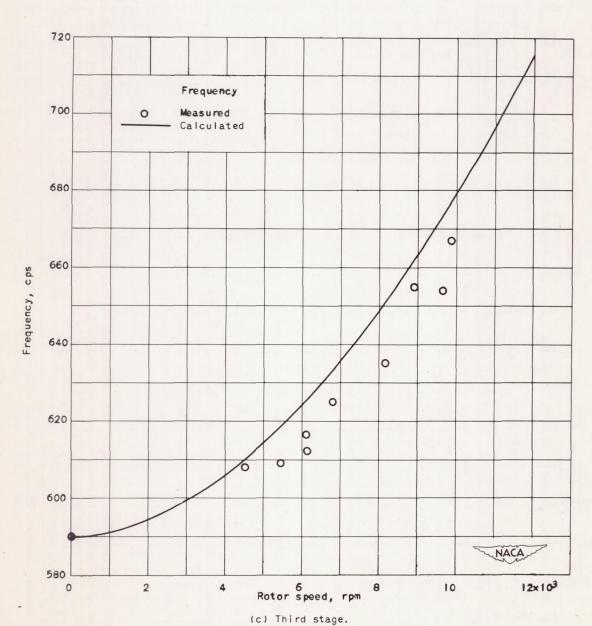
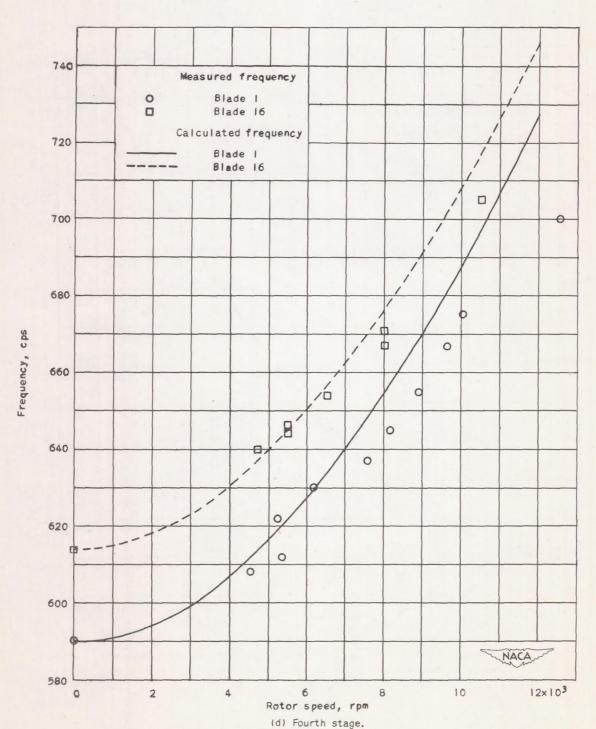
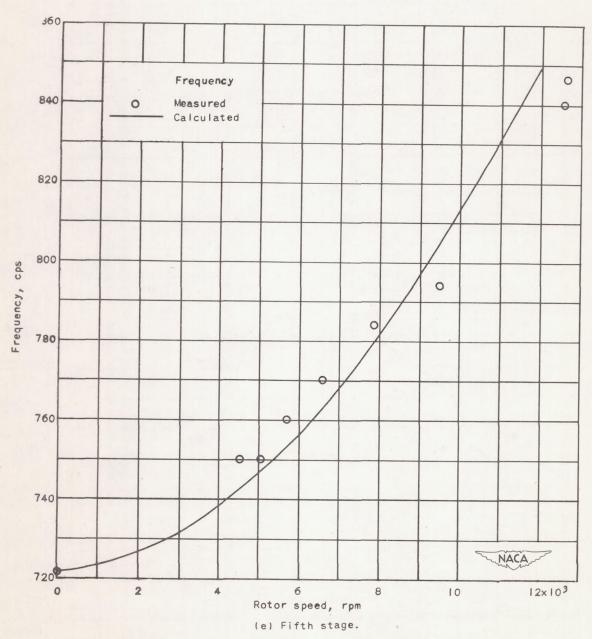
Figure 8. — Critical-speed diagram showing measured and calculated first bending-mode frequencies.

The first bending-mode frequencies, as determined from the oscillograph records, are shown plotted against rotor speed in figure 8. The curves of the statically measured natural frequencies corrected for the effect of centrifugal force in accordance with reference 3 are also shown on the figure. An average line drawn through the experimental resonant points has a slightly lower slope than the calculated line. This discrepancy is probably due to the variance between the fixed blade mount assumed for the calculations and the actual bulbous-root mounting arrangement used throughout the compressor. Also, the assumed deflection curve used in the calculations differs from the true deflection curve of the vibrating blade. Figure 8(d) is of special significance because the natural frequencies of two blades of the fourth stage are plotted. Considerable difference in the natural static frequencies of these two blades can be noted. In reference 1, it is stated that at rated speed (17,000 rpm) the frequencies of all blades might approach the highest blade frequency in the stage because the centrifugal force and thermal expansion raise the frequency by tightening the bulbous blade root. This conclusion, though generally true, is contradicted in the compressor as indicated by figure 8(d) and more clearly by figure 9, which is similar to figure 8 except that different coordinates are used, frequency squared and revolutions per second squared, resulting in straight-line relations. No convergence of lines through data points for the two blades occurs with an increase in speed. This fact was noted in the other stages of the compressor also but the fourth stage was arbitrarily chosen as an example.

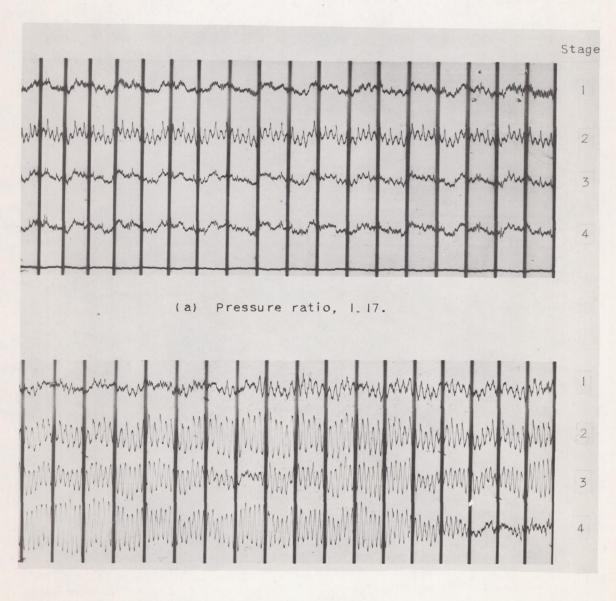
Figure 10. - Effect of varying pressure ratio at rotor speed of 8190 rpm.

The effect of changing pressure ratio of the compressor by throttling the exhaust is clearly shown in figure 10. All gage signals were taken at the same amplification and rotative speed (8190 rpm) at pressure ratios of 1.17 and 1.54. The rotor speed was so set that the signal from stage 2 would be in fourth-order resonance at a pressure ratio of 1.17. The vibration amplitude of the secondstage signal was more than doubled by the pressure-ratio increase; the third- and fourth-stage blades vibrated at 4.65 and 4.72 orders, respectively, at a pressure ratio of 1.54 and did not vibrate at the low pressure ratio. Furthermore, no correlation was apparent between the high and the low amplitudes of the second-, third-, and fourthstage signals at a pressure ratio of 1.54. These effects of change in pressure ratio were investigated at several other rotative speeds and the same results observed. All stress measurements were comparatively low but the limited driving power did not permit operation at the rated conditions (rotor speed, 17,000 rpm; pressure ratio, 4.0).
